Topic: ALKY-ONE Corrosion Sealability Test

Rev. Date: 8/20/2013

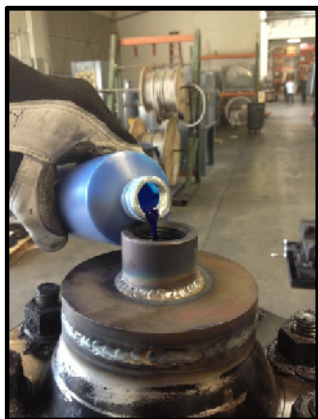
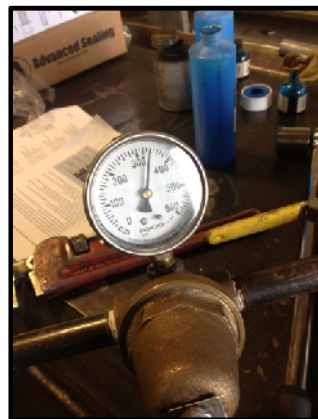
Once assembled, the test fixture was charged with blue ink and pressurized to 350-psi to simulate the upper limits of process operating pressure. (Figures 4 and 5) Of primary interest was the distance the ink penetrated between the chamfered flanges and the gasket.
