All Sealing Problems can be Fixed

A Guide to Leak-free Sealing

David Clover, Advanced Sealing and Supply Company

National Petrochemical and Refiners Association

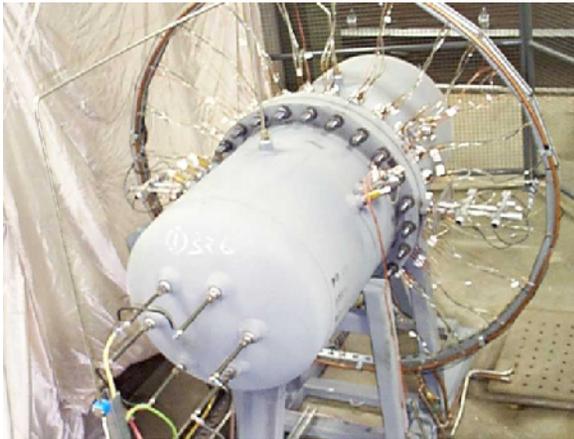
To that end Reeves and Brown designed the Radial Shear Tightness (RAST) test. The fixture was designed

to simulate the growth and shrinkage of flanges when exposed to sudden, dramatic temperature changes (see picture below).

In this test, the flanges were held at 600 degrees F., while the tubesheet was rapidly cooled to create 0.020" radial shrinkage. This process was repeated once each hour for 60 hours. The leakage past the gasket – and the amount of relaxation in the gasket – was monitored to assess gasket performance. The results of this testing were published by Dr. Warren Brown in his paper, "The Suitability of Various Gasket Types for Heat Exchanger Service". The chart below graphically compares the results of this test for the various materials tested.

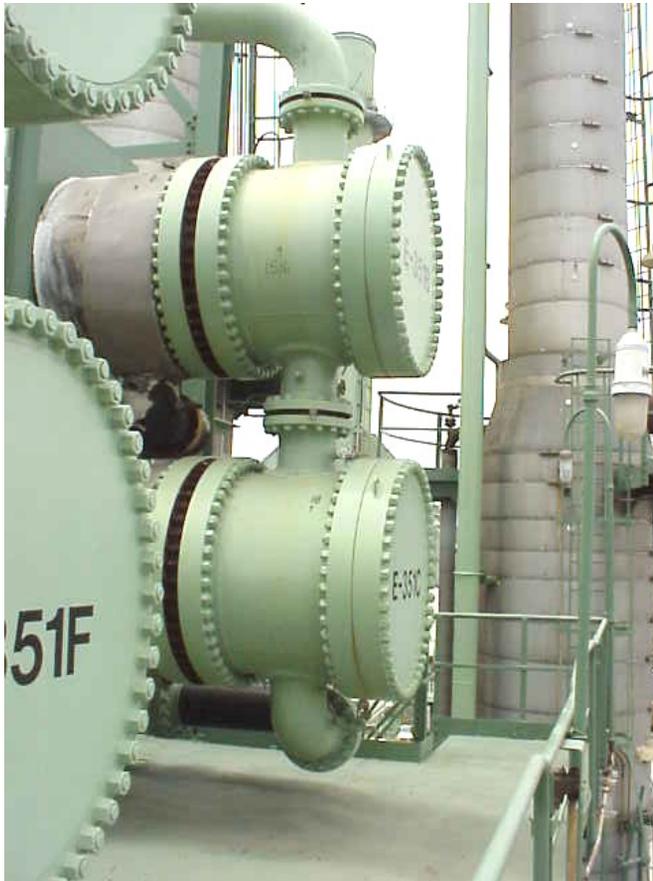
In the initial survey it was determined that nearly 40% of all heat exchangers sealed with traditional materials developed some level of leakage in their 3 to 5-year service cycle. Since switching to the upgraded products and procedures, thousands of gaskets have been installed, giving a great opportunity for comparison. Not one of the exchangers in which these solutions have been implemented has developed any leakage whatever. [The picture below shows Crude Unit exchangers (painted light green) after a 5-year run cycle.]

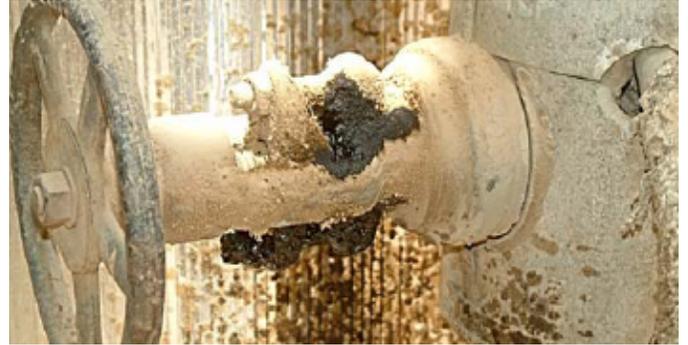
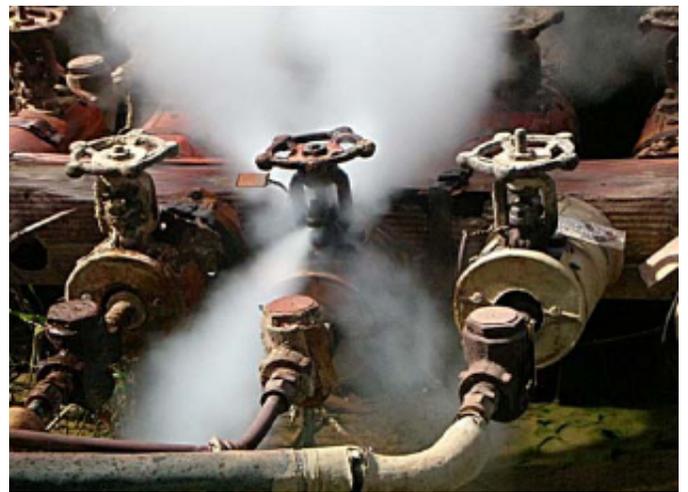
As with heat exchangers, it is no secret that valves occasionally leak. This is especially true of gate valves. Sights such as the ones below are not uncommon.

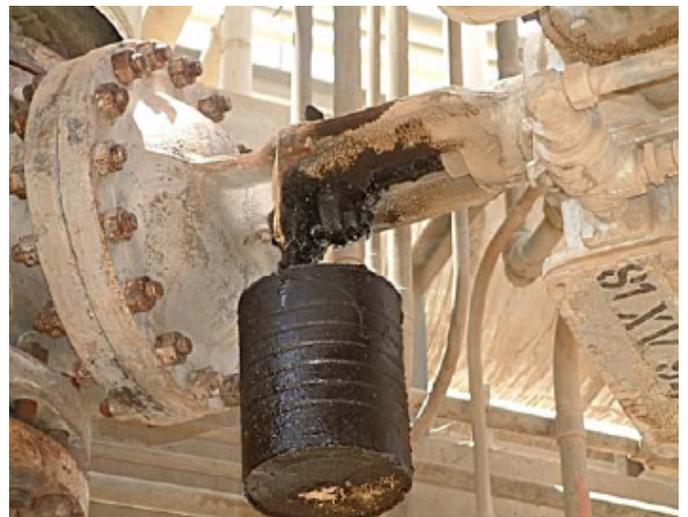
Depending on the criticality of the specific application, any number of "fixes" are utilized, including such creative ones as pictured below:

While such a “fix” may keep product from dripping to the ground, it does nothing to solve the root problem.
